NASA/TM—1998-208659

Space Shuttle Pinhole Formation Mechanism Studies

Nathan S. Jacobson
Lewis Research Center, Cleveland, Ohio

November 1998

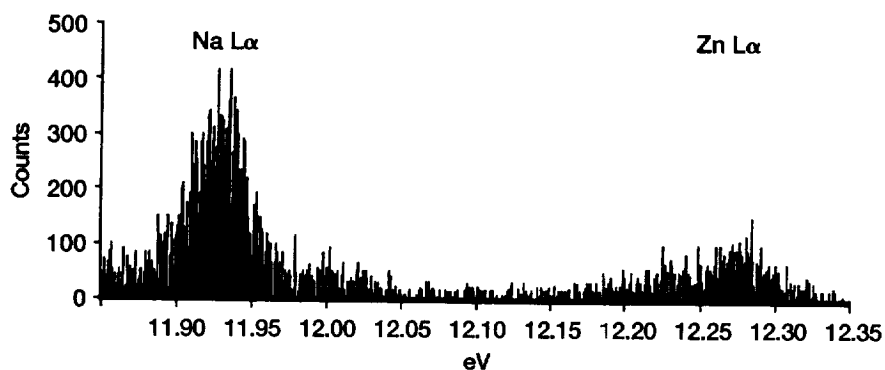
Figure 13.—WDS of the pinhole glass, indicating it is rich in both Na and Zn. This resolves the signal EDS peak in Figure 11 & 12.

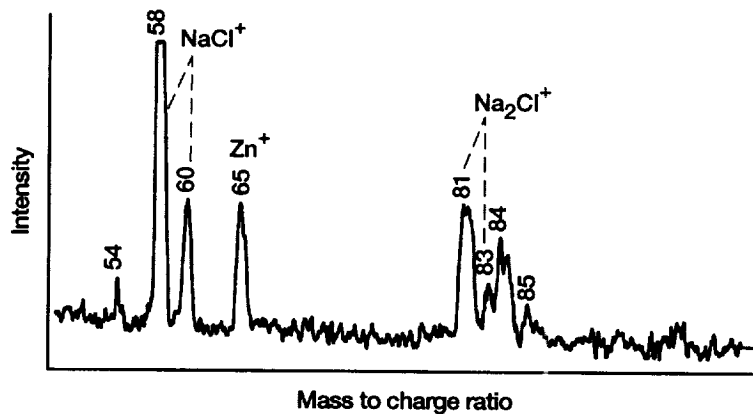
Figure 14.—Mass spectrometer trace showing gases coming off protected RCC removed from the shuttle. The trace indicates the presence of both NaCl(g) and Zn(g).

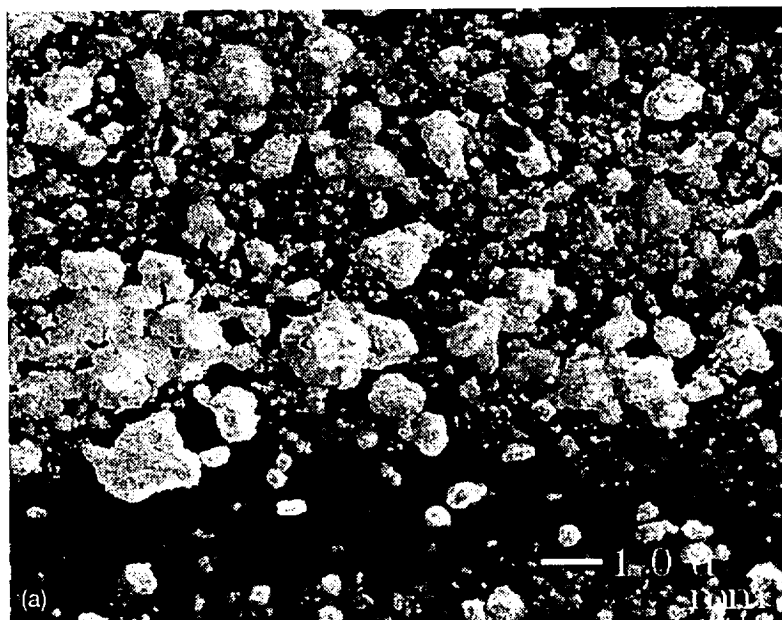
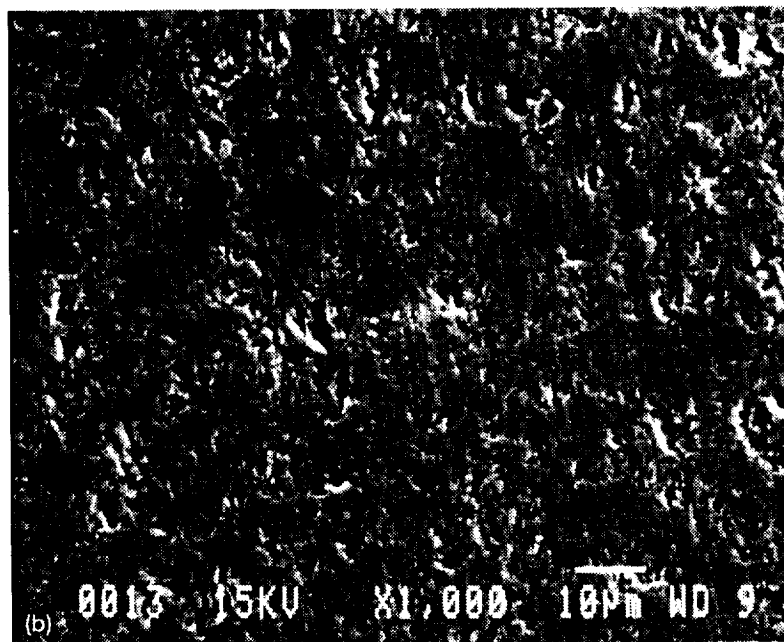
A limited number of furnace tests were done to try to understand some of the high temperature reactions. The conditions are listed in table I. The results of a simple test of ZnO and SiC are illustrated in figure 15 and listed in table II. It appears that ZnO enhances the oxidation of SiC by a factor of two. This is very likely by the Zn doping the SiO₂ network and leading to faster transport rates. Since the ZnO-SiO₂ eutectic is high (fig. 16—1705 K), no liquid is formed under these conditions. A solid system exhibits much less attack than a liquid system.

Figure 15.—CVD SiC with ZnO, 1 hr in 0.05 atm air. (a) Surface view showing ZnO and Zn_2SiO_4 on surface after 1000 °C treatment. (b) Surface product in 14(a) removed by treatment in aqueous HF solution to reveal limited surface attack after 1200 °C treatment.

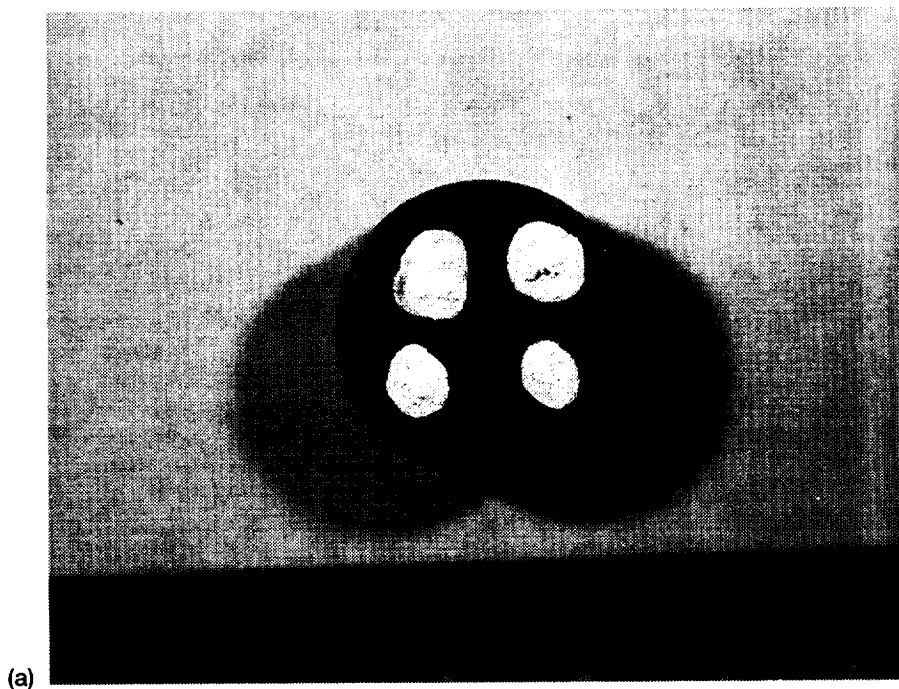
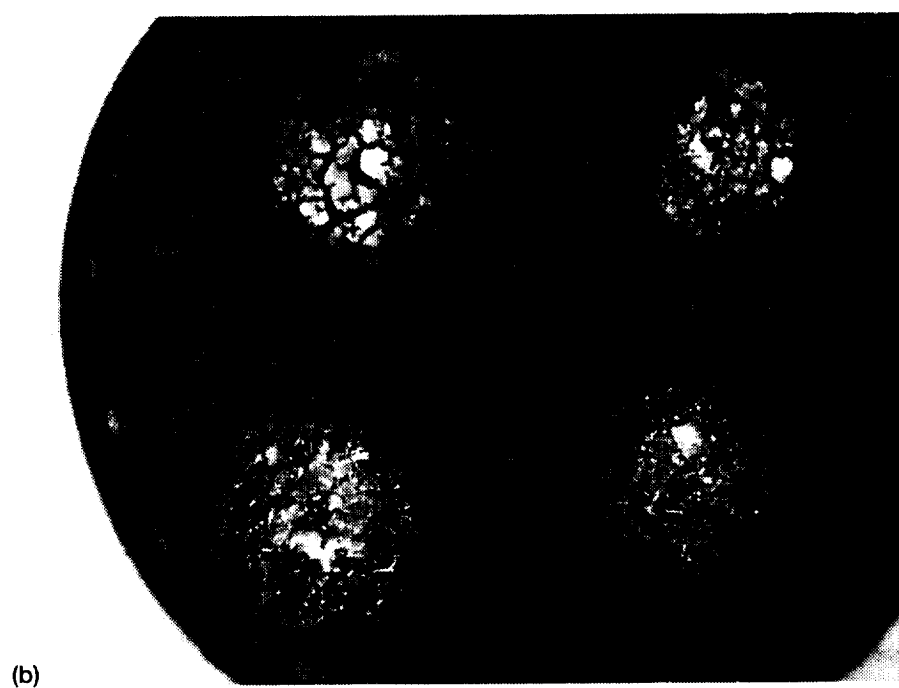
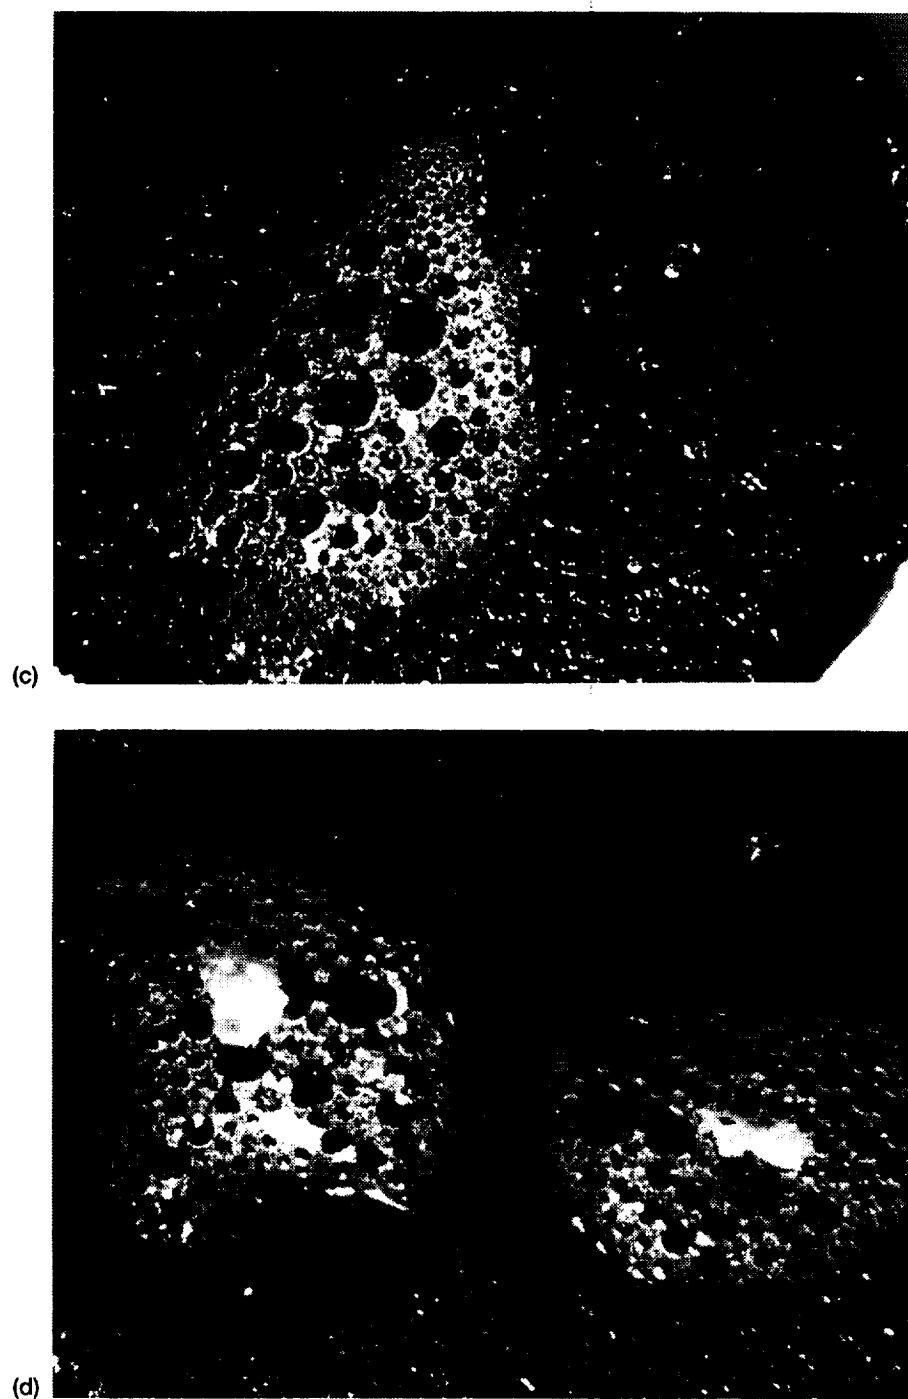
Some tests were also done on the RCC material + ZnO. In this case extensive reaction was noted, as shown in the optical micrographs in figure 17. This bubbly, friable glass was reminiscent of the glass observed on the shuttle specimens. This glass was further examined with the EPMA. First a region which appeared to be Zn-rich glass on SiC was examined. This is shown in figures 18 and 19. These figures indicate a thick layer of Zn-rich glass, with a thin layer of SiO₂ adjacent to the sample. The large bubble indicates extensive gas generation. Figure 19 shows an enlarged region with what are very likely SiO₂ crystallites adjacent to the SiC. This is reminiscent of the glass observed on the shuttle specimens.

These observations support a zinc oxide based pinhole mechanism and to a less extent a NaCl-based mechanism discussed in an earlier report (ref. 10). Consider the zinc oxide based mechanism. The key observation here is in figure 17. The presence of ZnO on the protected RCC material leads to the formation of a thick Zn-Na-Si-O glass, with a lot of entrapped bubbles. The additional silica in this glass cannot be from the silica which is already a part of the RCC material, but rather must come from oxidation of the SiC layer. This leads to consumption of the layer and also accounts for the extensive gas and resultant bubble formation. Thus a sequence of reactions is likely:

Figure 17.—Protected RCC material and ZnO (a) Before reaction. (b) After 1 cycle in 0.092 atm air for 0.5 hr at 1200 °C.

Figure 17.—Concluded. (c) After 4 cycles in 1 atm air. (d) After 27 cycles in 1 atm air. These cycles are 0.5 hr at 1200 °C.

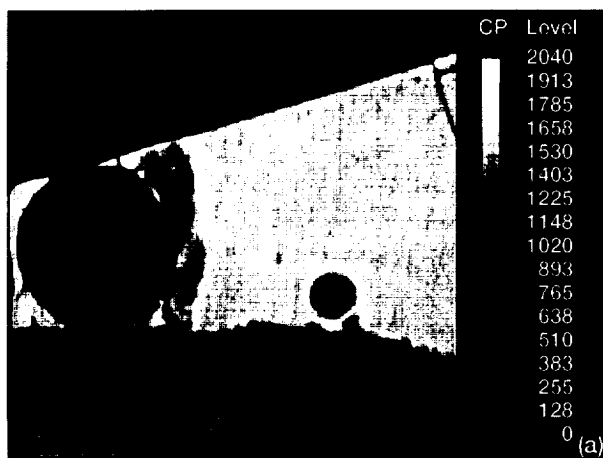
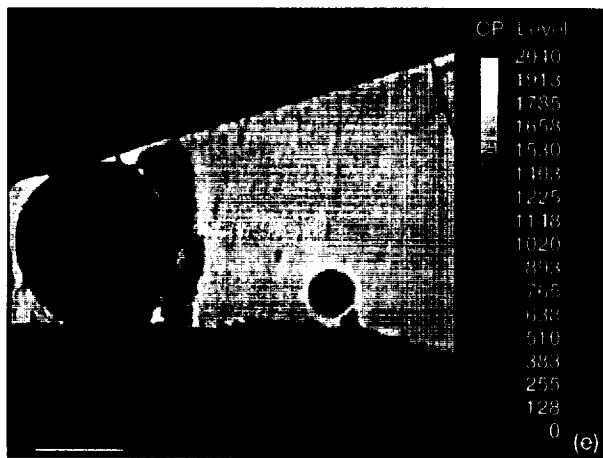
Figure 18.—Protected RCC material reacted with ZnO for 27 0.5 hr, cycles at 1200 °C in 1 atm air, region showing ZnO-Na₂O-SiO₂ glass adjacent to SiC. EPMA results—BSE image and associated elemental maps.

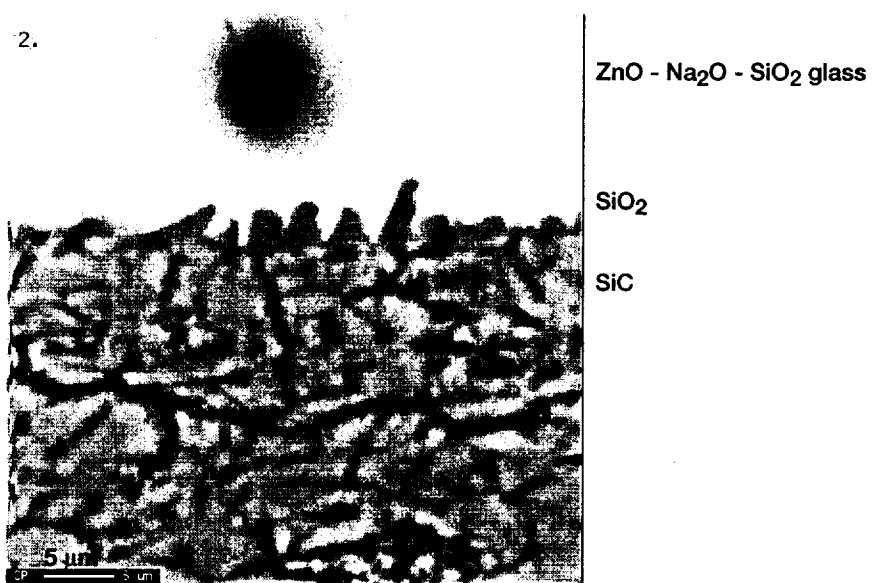
Figure 19.—Protected RCC material reacted with ZnO for 27 0.5 hr, cycles at 1200 °C in 1 atm air, region showing ZnO-Na₂O-SiO₂ glass adjacent to SiC. High magnification photograph showing glass/SiC interface—note intermediate layer of SiO₂ crystallites.

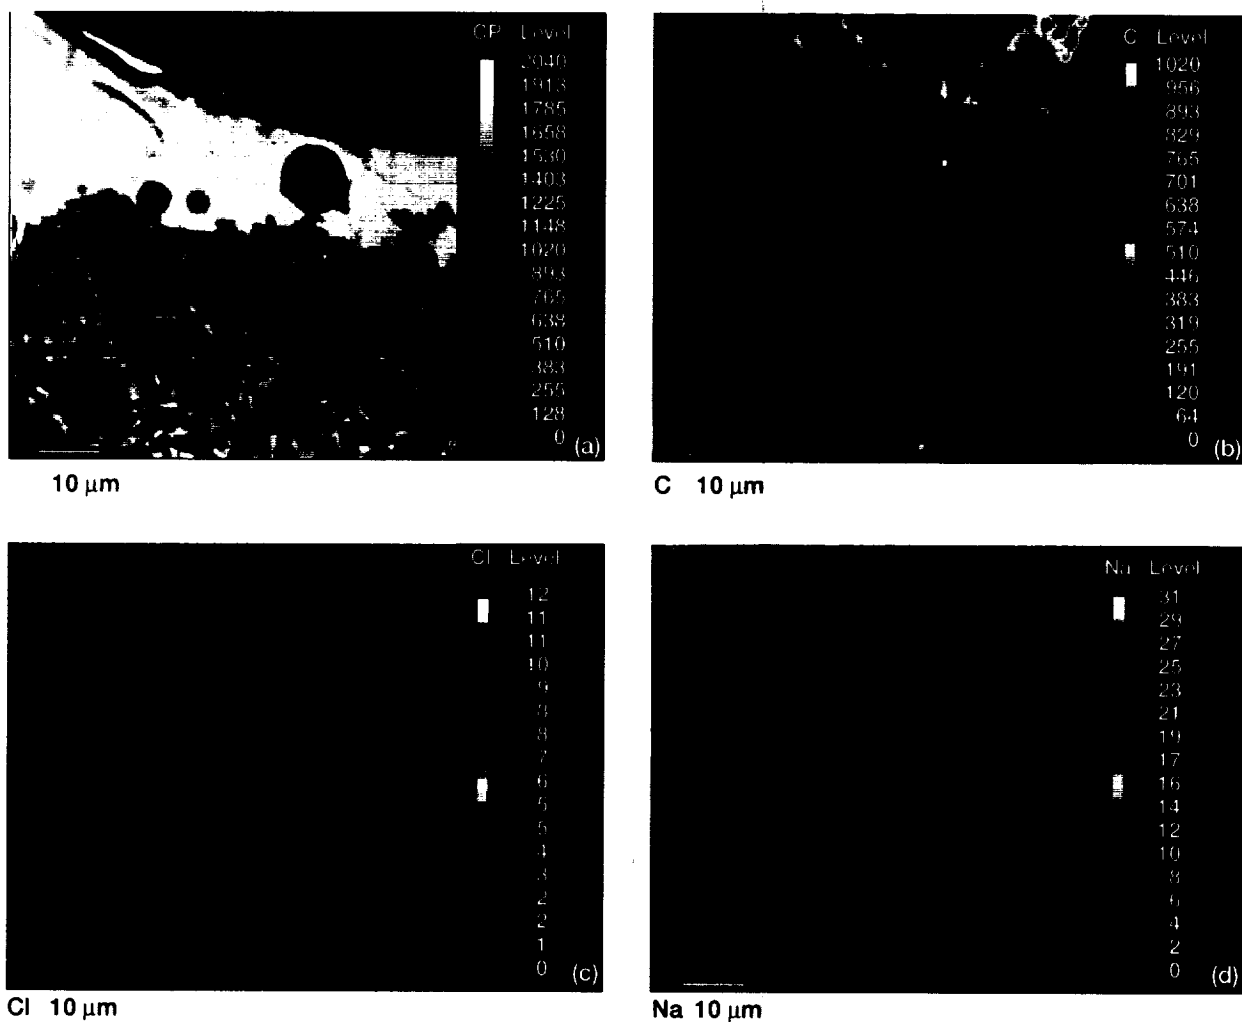
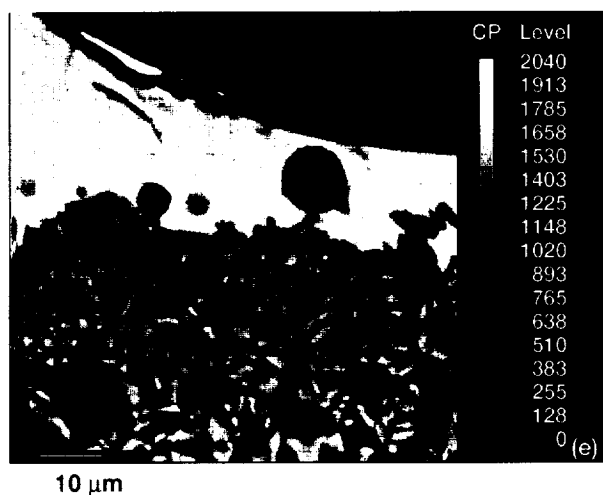
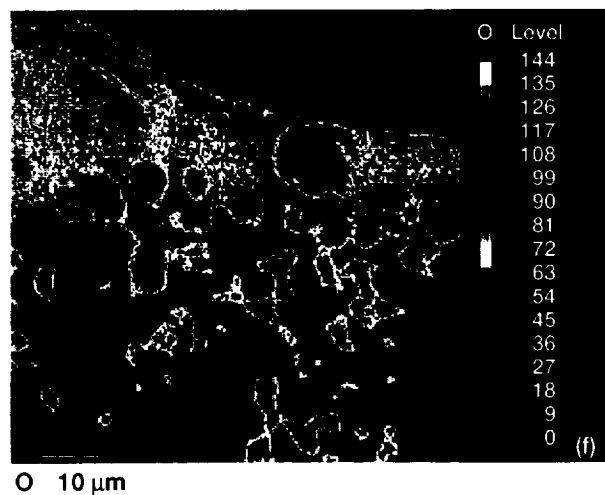
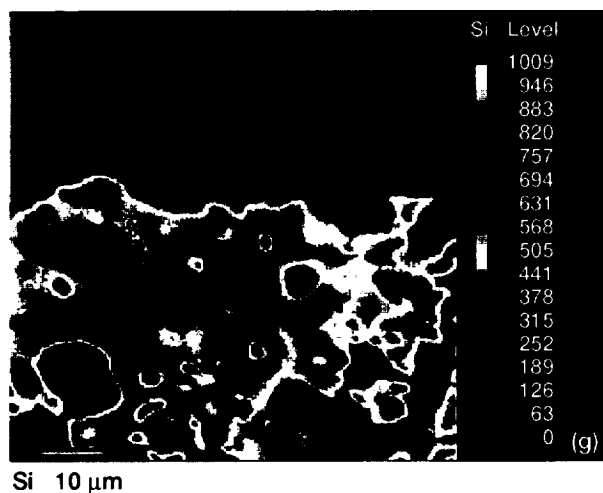
Figure 20 a region where the Zn-rich glass was adjacent to a SiO₂ filled region. This SiO₂ region was likely formed in processing by the TEOS vacuum infiltration/decomposition to silica step. The significant point here is that the zinc rich glass maintains a distinct layer from the silica.

Figure 20.—Protected RCC material reacted with ZnO for 27 0.5 hr, cycles at 1200 °C in 1 atm air, region showing ZnO-Na₂O-SiO₂ glass adjacent to a portion of the SiC layer, rich in SiO₂. EPMA results—BSE image and associated elemental maps.

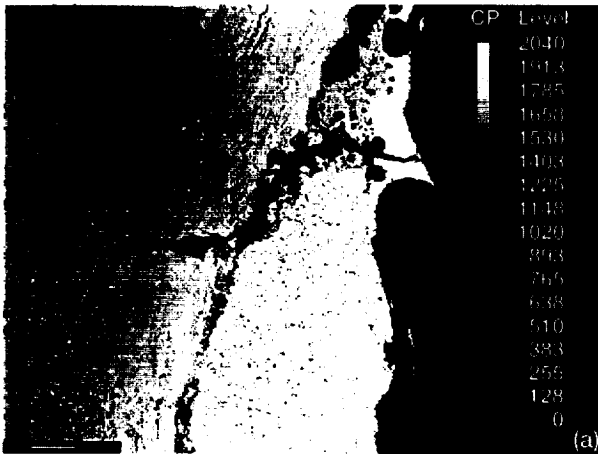
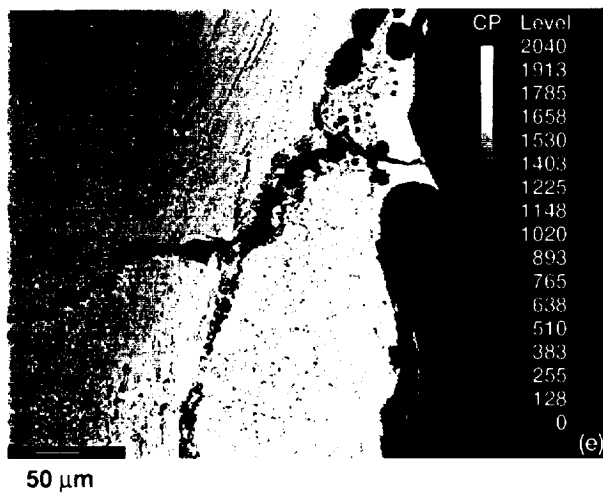
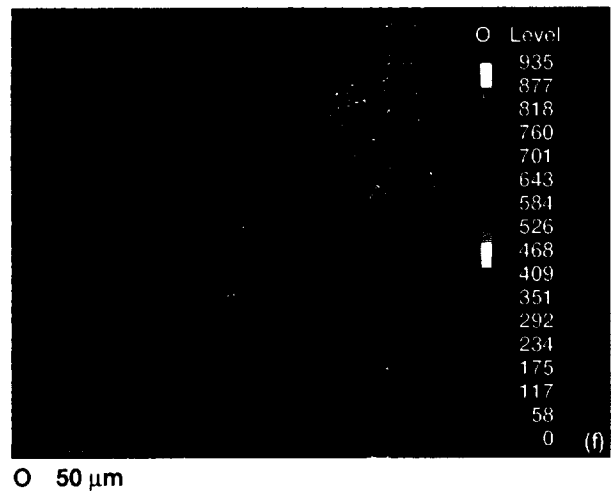
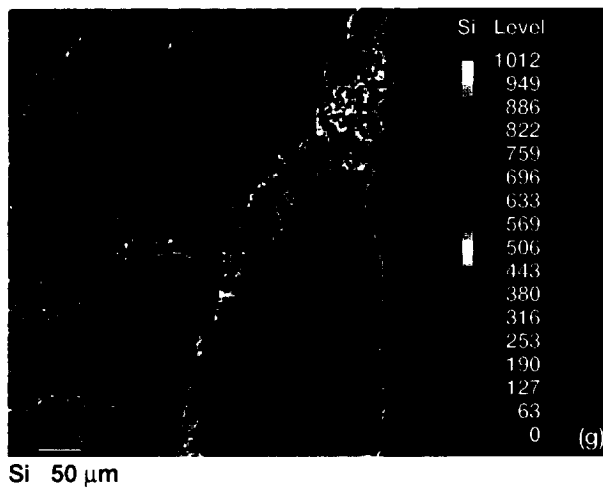
In order to explore the effects of both ZnO and NaCl on the RCC material, a coating of NaCl was put on the Zn-rich glass. The EPMA results are shown in figure 21. Generally most of the NaCl remains on top of the ZnO-rich glass with little interaction. However the elemental maps suggest that some Cl flows down a crack.

Figure 21.—Protected RCC material reacted with ZnO for five 0.5 hr, cycles at 1200 °C in 1 atm air, region showing ZnO-Na₂O-SiO₂ glass adjacent to SiC. After the four cycles a film of NaCl was sprayed on this sample and the sample was cycled one more time. EPMA results—BSE image and associated elemental maps. Note NaCl in primarily on top but some appears to have penetrated the crack.

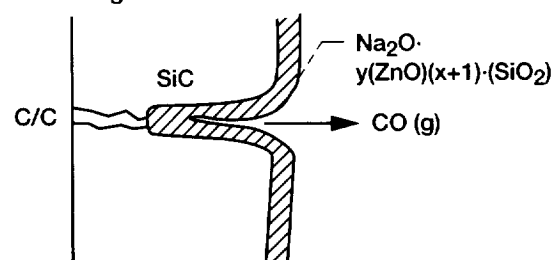
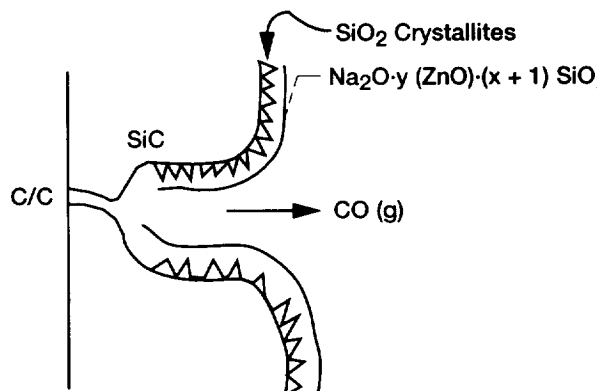
Figure 23.—Schematic of proposed pinhole formation mechanism, based on ZnO- Na_2O - SiO_2 crack enlargement. Steps (c)-(e) repeat, enlarging crack.

Figure 23 is a schematic of a proposed mechanism. ZnO particles lodge near existing cracks. Then a Na₂O · y(ZnO) · x(SiO₂) glass forms due to reaction of the ZnO with the sodium silicate sealant via reaction (3). This reactive glass can dissolve the stable SiO₂ layer on the SiC in the crack via reaction (5). Further rapid oxidation of SiC can occur via transport through the Na₂O-ZnO-SiO₂ liquid via reaction (4). This oxidation and dissolution effectively leads to consumption of SiC and enlargement of the crack. In time the Na₂O-ZnO-SiO₂ liquid will become saturated in SiO₂ and the reaction will stop. This type of oxidation and dissolution has been discussed in the introduction and is commonly observed in high temperature Na₂O-induced corrosion reactions (ref. 2 and fig. 4).

(c) $\text{Na}_2\text{O} \cdot y (\text{ZnO}) \cdot x (\text{SiO}_2)$ dissolves SiO_2 , thereby attacking SiC.

(d) SiO_2 rich $\text{Na}_2\text{O} \cdot y (\text{ZnO}) \cdot (x+1) \text{SiO}_2$ is pushed out by escaping gases, exposing fresh SiC.

(e) SiO_2 , depleted $\text{Na}_2\text{O} \cdot y (\text{ZnO}) \cdot x (\text{SiO}_2)$ flows into crack, attacking SiC.

(f) Crack is gradually enlarged. Final microstructure is shown below.
